## **A Permanent Repair for Drum and Cymbal Stands**

**R. Chris Berry 2024-12**

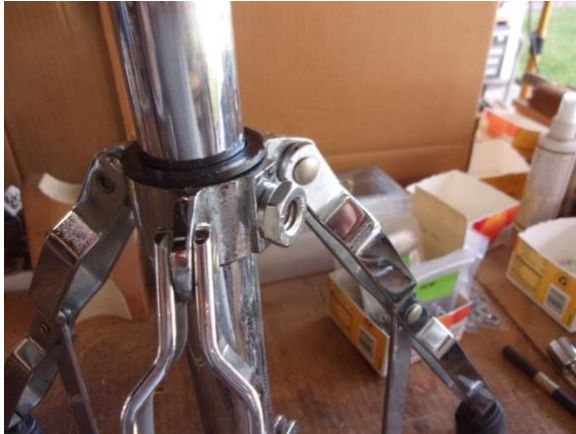
Ludwig stand with stainless insert, locking nut, and lockwasher.

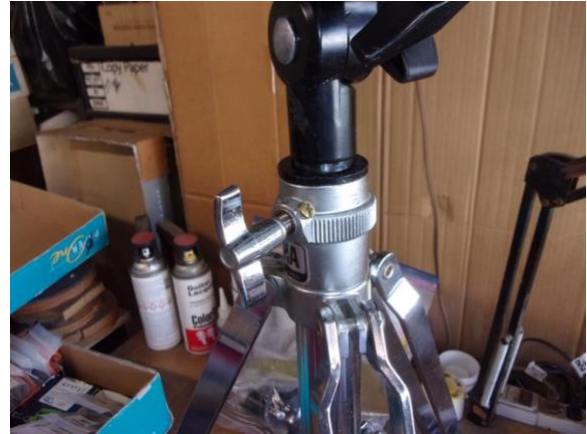
Yamaha stand with steel insert, shims, and 6-32 locking bolt.

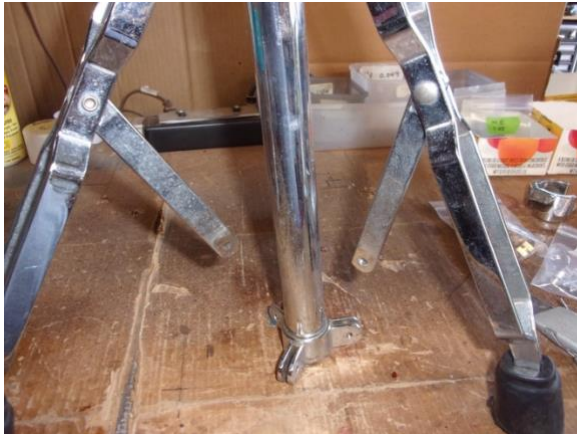
Step 1.1: Disassemble the stand legs. This will prevent marring the stand while drilling and tapping.

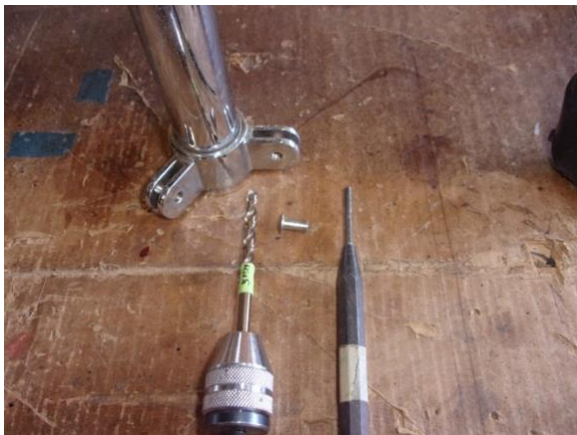
Step 1.2: Drill out the rivets, 5mm in this case. Tap the remainder of the rivet out with a punch. Disassembly may involve removing a spring pin which holds the bottom on. Use an appropriate punch. Save all the parts in milk carton bottoms or similar. I also use plastic pencil boxes or small trays for this purpose.

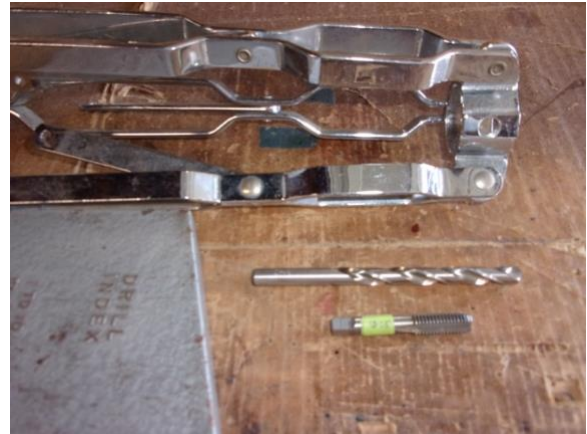
Step 2: Drill out the stripped hole. The tap drill for m10-1.5 is m8.5. Tap the hole m10-1.5. Note: Use oil for lubrication or the tap will wear very quickly or possibly break. Tap a half turn, then break the chip by withdrawing a quarter turn. Patience is required for this to work right.

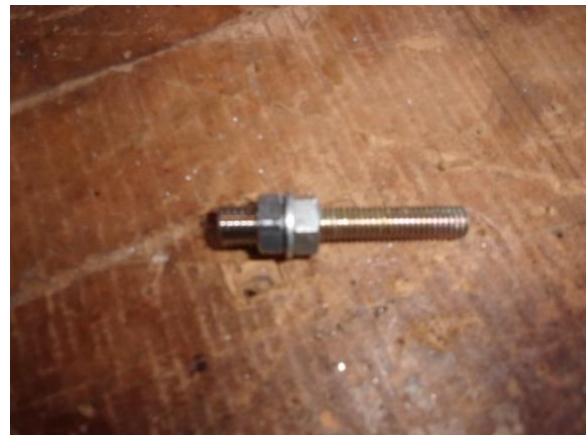
Step 3.1: Make a mandrel for the inserts. This is an m8-1.25 bolt with two nuts and a lockwasher. The short end is just shy of the length of the insert.

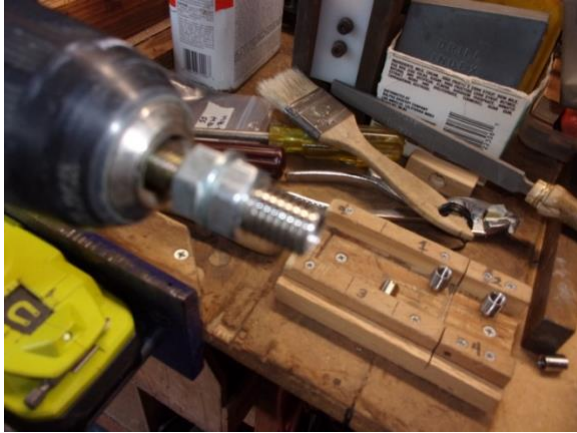
Step 3.2: Make chamfer on both ends of the insert. This insert is stainless and worked best with a medium to fine cut mill file. The mandrel will also be used to install the insert. Check the fit of the m10-1.5 locknut. If the nut will not thread on to the insert it may be due to the inside diameter of the thread. This one was a few thousandths larger than the tap drill. The solution is to measure with a caliper. I drilled the locknut (letter R) to solve this.

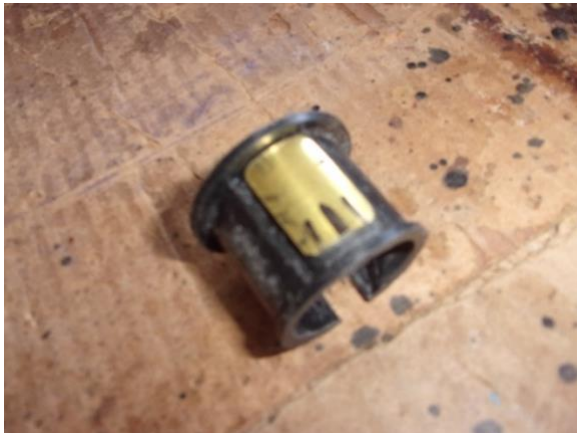
Step 4.1: Repair the bearing plate if necessary. This one is made of 0.040" brass.

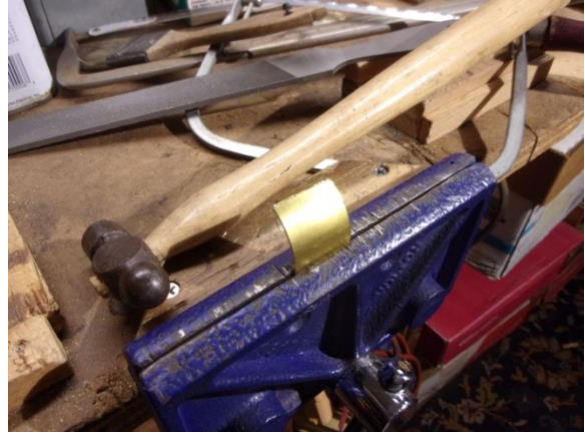
Step 4.2: Bending the new bearing plate in the vice. Bend from the middle to the end.

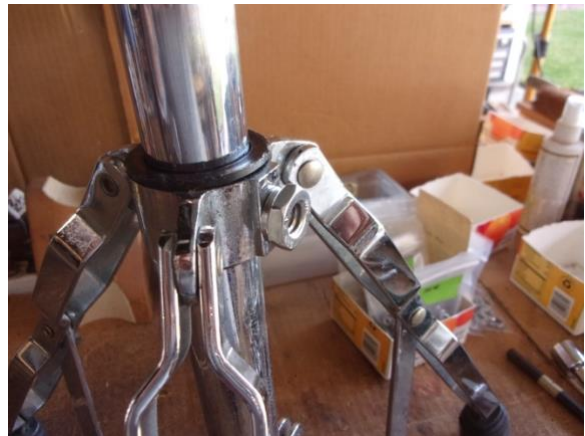
Step 5.1: Install the insert using an m10 locknut (thin) and an m10 lockwasher. Having the plastic insert and plate in place helps ensure that the insert does not go in too far.

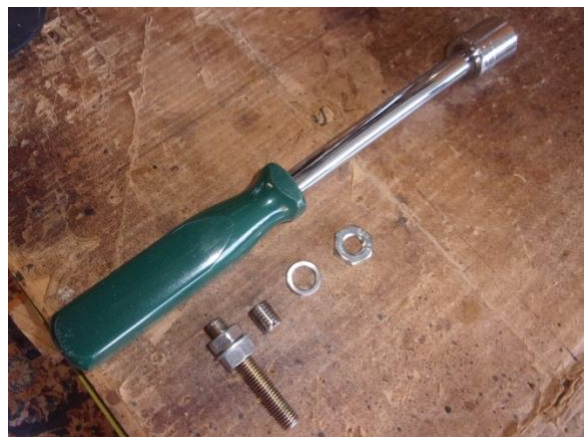
Step 5.2 Tools used for insert installation.

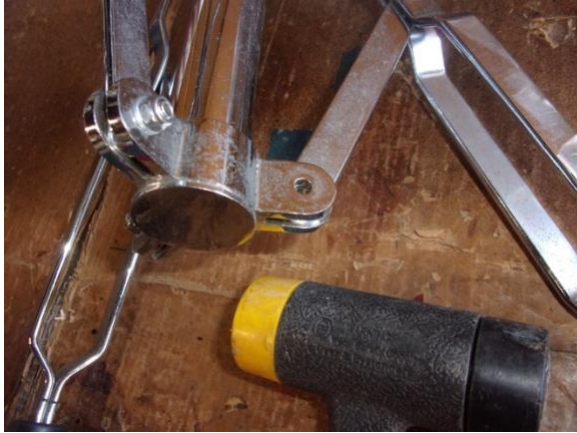
Step 6: Reinstall the bottom fitting using the spring pin, punch, and a soft hammer.

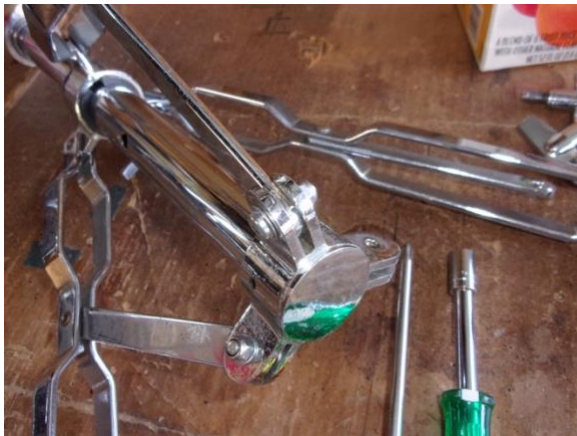
Step 7.1: Bolt the legs back together.

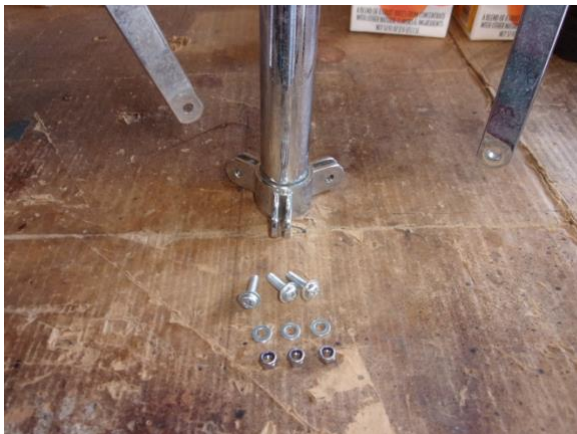
Step 7.2: M5 parts for stand reassembly.

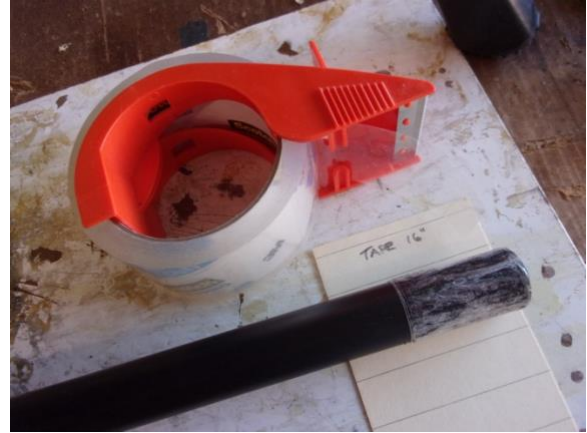
Step 8.1: Stand no. 1 needed some packing tape in two places to adapt it to the repaired stand base.

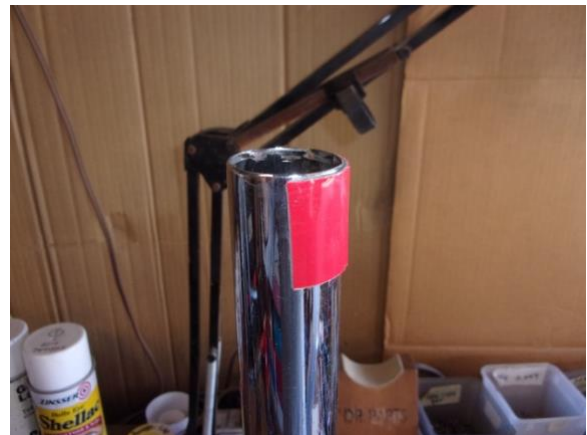
Step 8.2: Outdoor foam tape on the bottom tube.

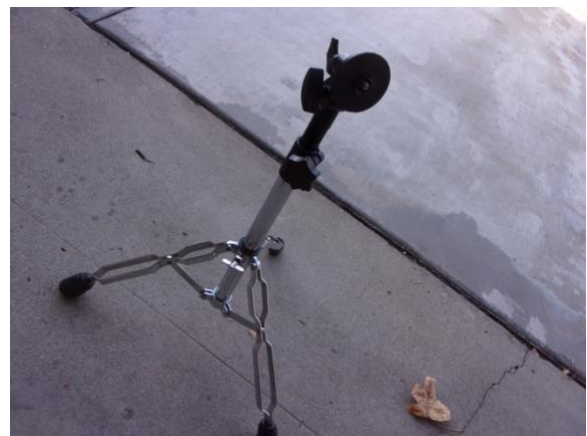
Step 8.3: The completed stand is ready for the NXT5 bass at standing height.

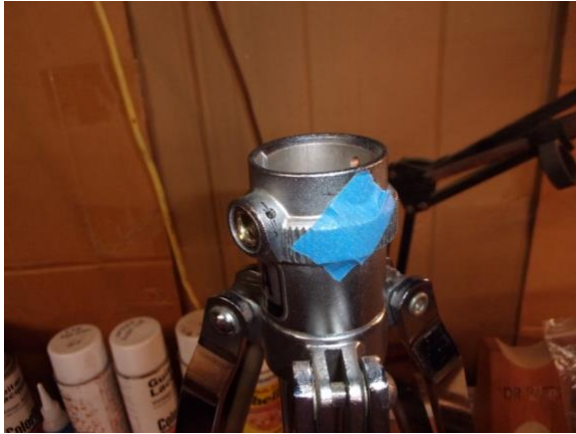
1. Yamaha stand with new insert.

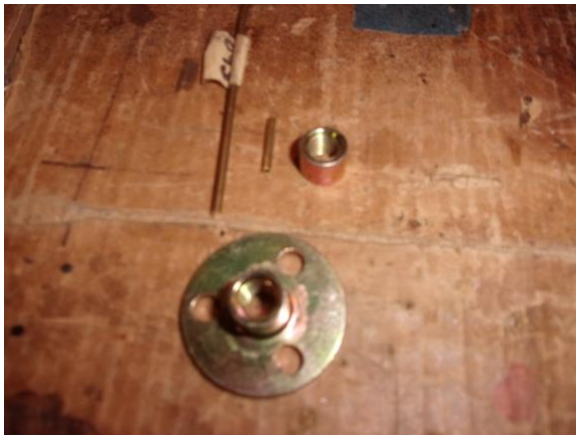
2. Making the insert. A furniture T nut was just right for this repair. The internal thread is m8-1.25 and the outer diameter is m12. The flange was cut off with a metal cutting blade (32 tpi) in a coping saw frame.

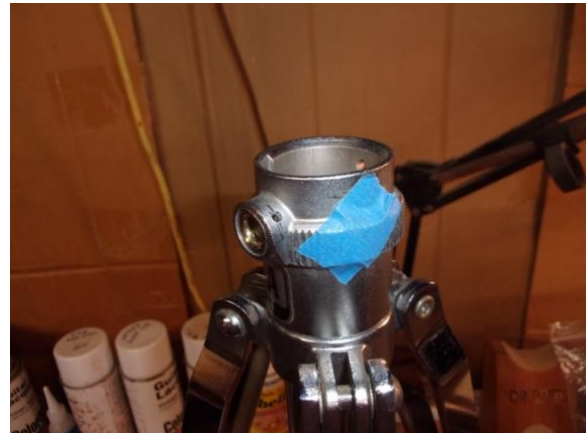
4. The insert was secured with a 6-32 brass bolt about 1/4" long. The tap hole (#36 drill) was threaded through the casting and one side of the insert. Note that I tried 3/32" pins (a rod and also a tube) and neither worked well. A spring pin would be too hard for this application. If it fouled the threads the problem could not be corrected with a tap.

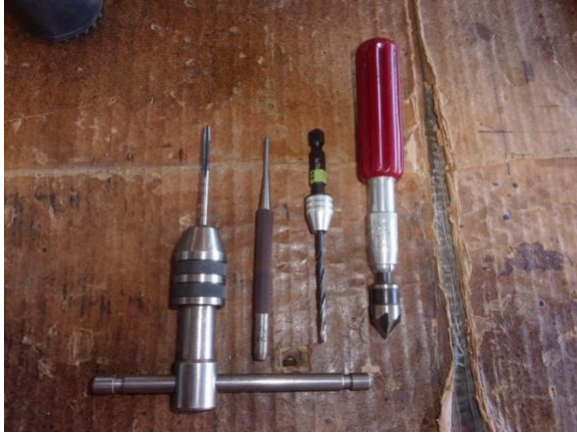
5. Threading tools. The hobby knife handle has been drilled to fit the countersink.

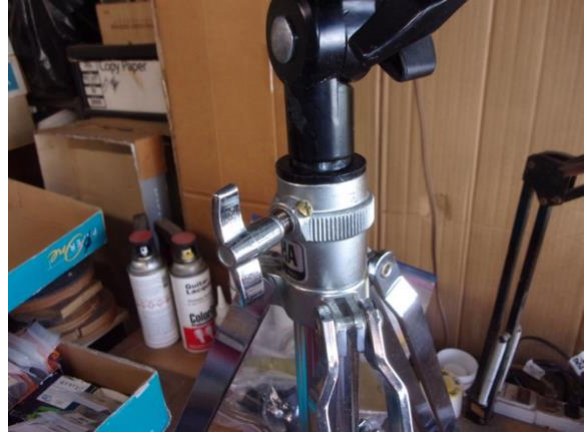
7. The completed stand with the NSD hardware.

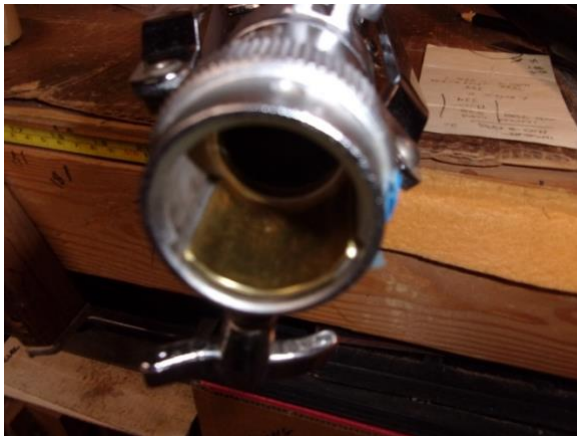
6. A new bearing plate was made and installed.

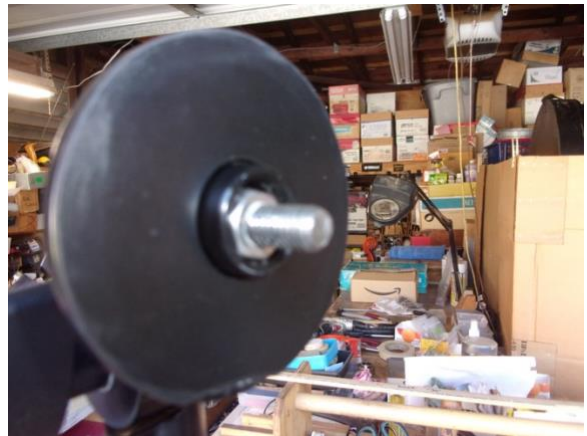
8. Incidentally, the threads on the top bolt for mounting the bass had to be chased in order to work properly.
