## Repair of a tc electronic BG250-208 bass combo

Summer thunderstorms and rainy weather in July 2020 - time for an overdue repair.

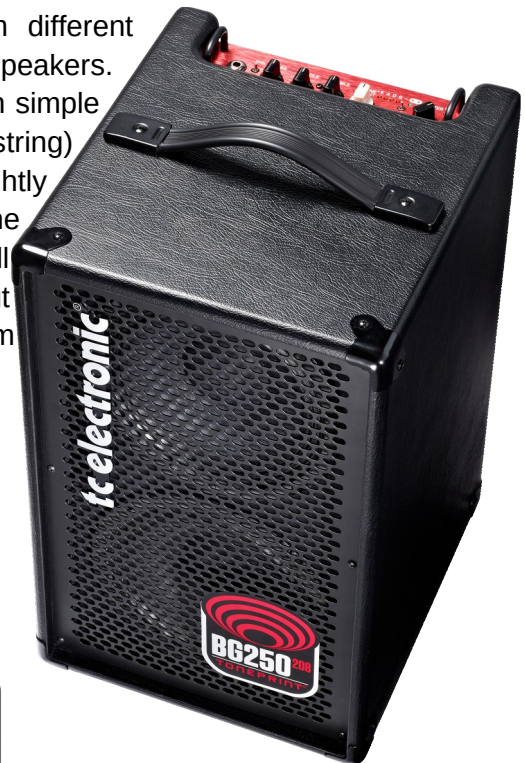
Fig. Right: BG250-208, Source: tc electronic

Fig. Below: BG250 Different Amplifier Modules, Source: tc electronic

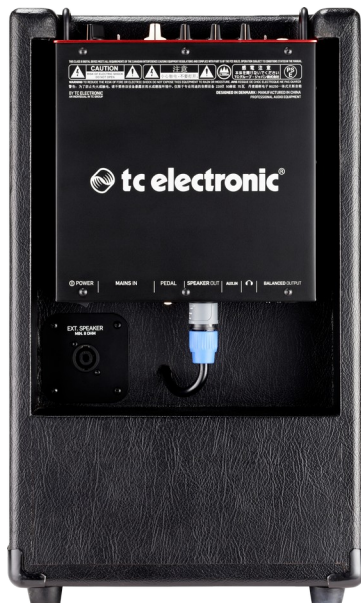
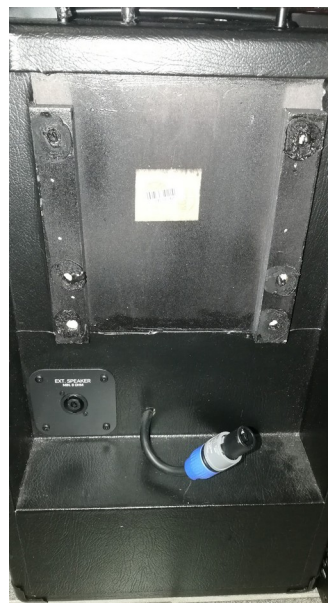
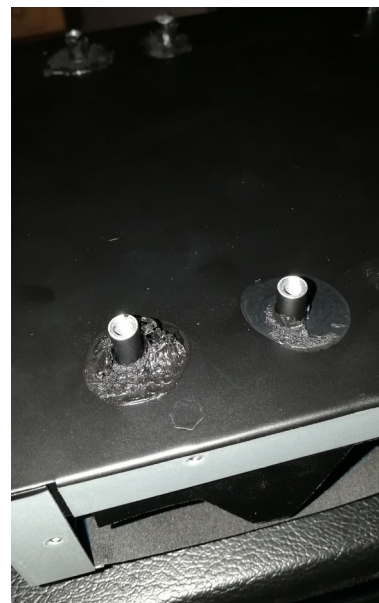
Fig. Left: back of the box before (source: tc electronic), middle: with the amplifier module detached, Right: M5 threaded sleeves and bitumen adhesive on the amplifier module

So when you have somehow got rid of the six M5 screws without damage (ideally with a Torx, the size of which depends on how much of the really rock-hard locking paste you get out of the screw heads) the amplifier can be removed. But anyone who thinks that it can now simply be removed from the back wall has not yet got to know the threaded sleeves, which are probably also sunk into black painted wooden strips for safety, and the bitumen adhesive strips. So pull it off very carefully and with gentle force!

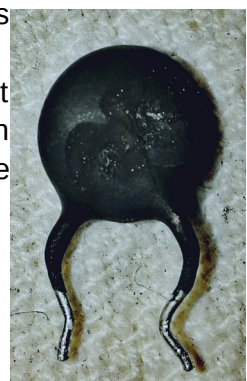
Two small craters are only visible on the back, which suggest the defect and flaking of the housing material. Together with the smoke traces on the inductance coil (see photo on page 3), which I cleaned before

soldering in the replacement type, this component was clearly damaged. One more thing: The M5 Torx screws for connecting the box and amplifier can be freed from the hardened safety paste to some extent with WD40. However, if the screw heads had to be drilled out, new screws are required.

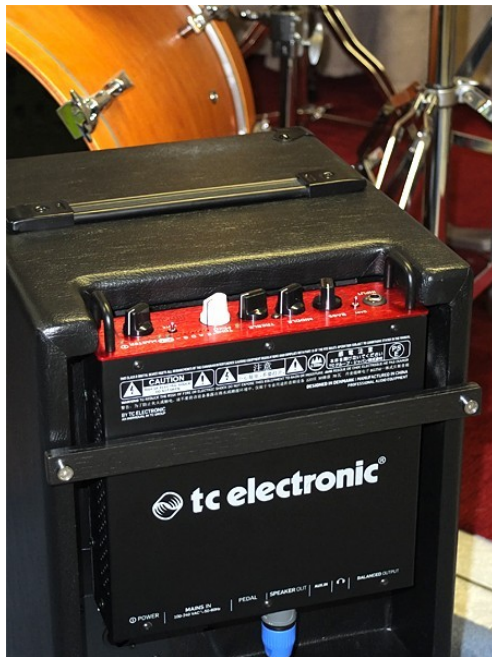
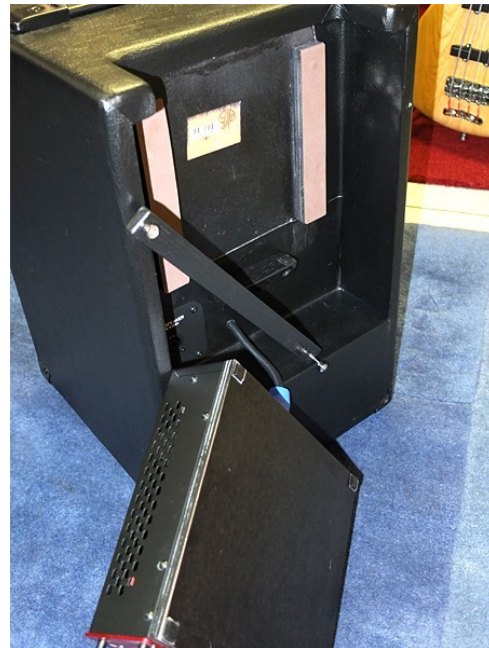
Many bass players wrote that the combo had been rebuilt in such a way that the amplifier could be more easily removed from the speakercab in order to be used as a top. This may be an alternative for one or the other of you. (Source: Bassic.de, Onkel Bennat)

(Fig. BG250-208 Modification, Source: Bassic.de, Onkel Bennat)
